HISTORIC RESOURCE STUDY

BANNACK STATE PARK

est.
Historical Research Associates
Missoula, Montana

July 1982

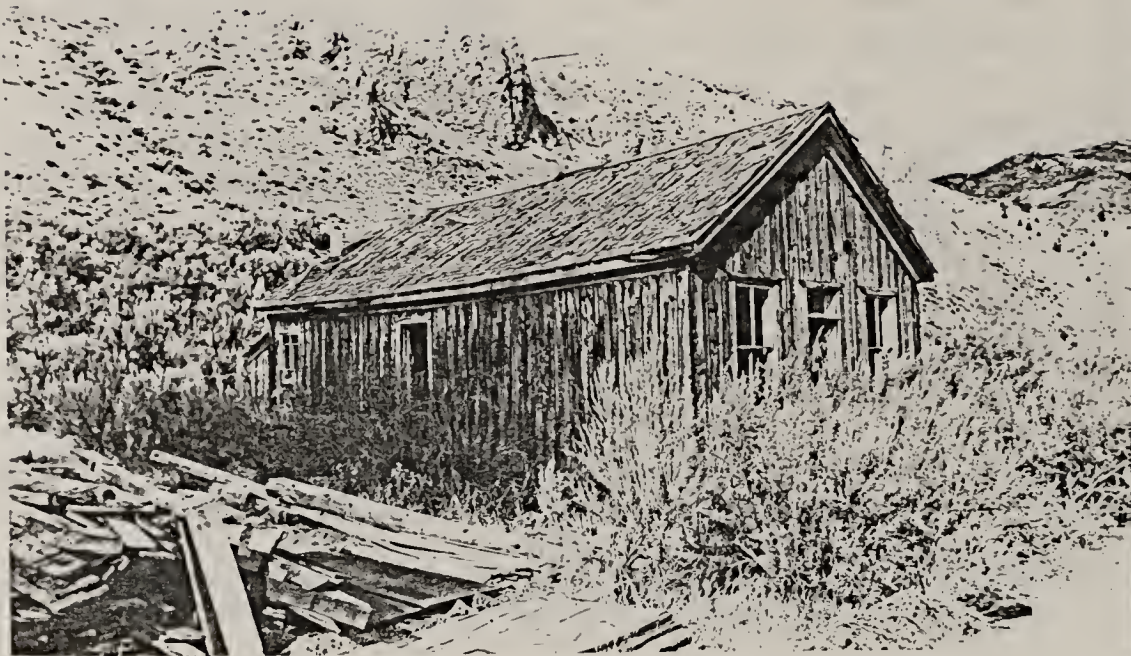
Figure 3-134. Looking northeast at residence.

This structure is a one-story wood frame residence with board-and-batten siding extending into the gable ends. There is no visible foundation other than a sill log. The pitched gable roof is covered with wood shingles over a circular-sawn board sheathing and has a brick chimney at the north end. Two-over-two double-hung wood sashes still exist in most of the windows, but the glass is missing. All of the doors are also missing. There is a frame lean-to addition with board-and-batten siding and a metal shed roof on the rear of the structure.

The interior has four rooms in the main structure. The structure is in poor condition. It slopes to the back and the center drops down because of possible foundation problems. The lack of windows and doors to keep out moisture, and a deteriorating roof present additional problems. A board-and-batten outhouse northwest of the structure has caved in.

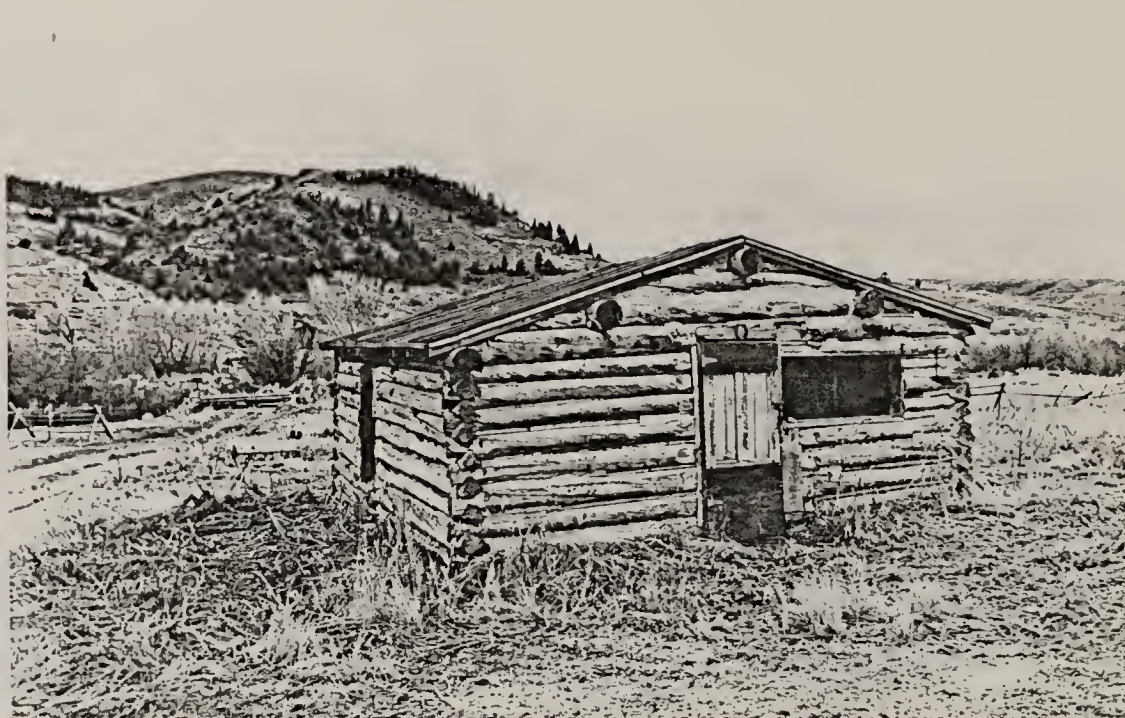
To the southeast of the residence is a one-story log structure with V-notched corners, a five purlin roof with board-and-batten roofing, and cement and lime mortar daubing with patches of Portland cement mortar daubing. There is a wood panel door and framed window openings. This structure is in fair condition, has no visible foundation, and has rotted sill logs.

Figure 3-136. Log structure to the southeast of HS #46.

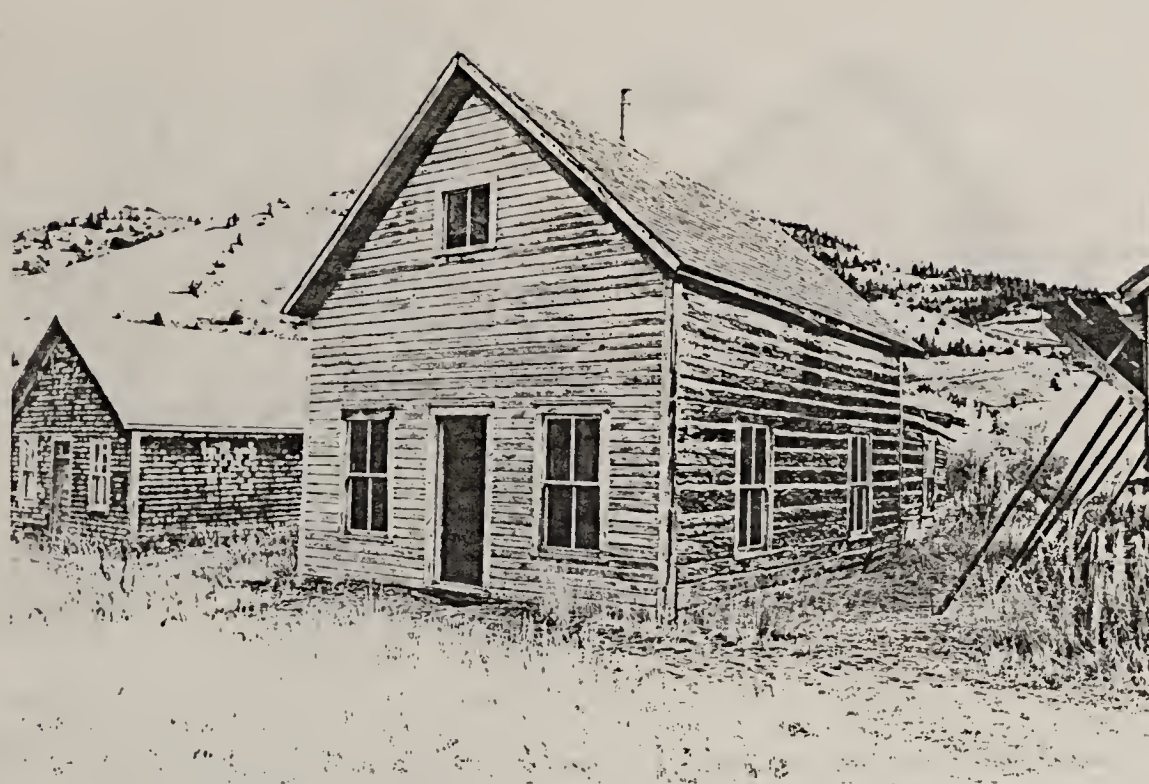
Figure 3-137. Looking southeast at residence.

This structure is a one and one-half story hand-hewn log residence with shiplap sided front facade. The front facade has a central doorway with flanking windows, a central fixed window in the gable end, and a projecting cornice. The roof is a high pitched gable with wood shingles, penetrated at the ridge by a metal stovepipe. A one-story hand-hewn log structure with gabled board-and-batten over sod roof has been added to the rear. Logs have cement and lime mortar daubing with evidence of whitewash finish. Windows are two-over-two double-hung type. The front door is missing.

The interior walls are hand-hewn log with a covering of heavy fibrous paperboard. The floors are buckled and water damaged. The building is in poor to fair condition, and rests on a stone foundation.

The property was acquired through donation to the State of Montana in 1954. In 1969, it was reroofed with cedar shingles, and in 1978, windows and doors were repaired.

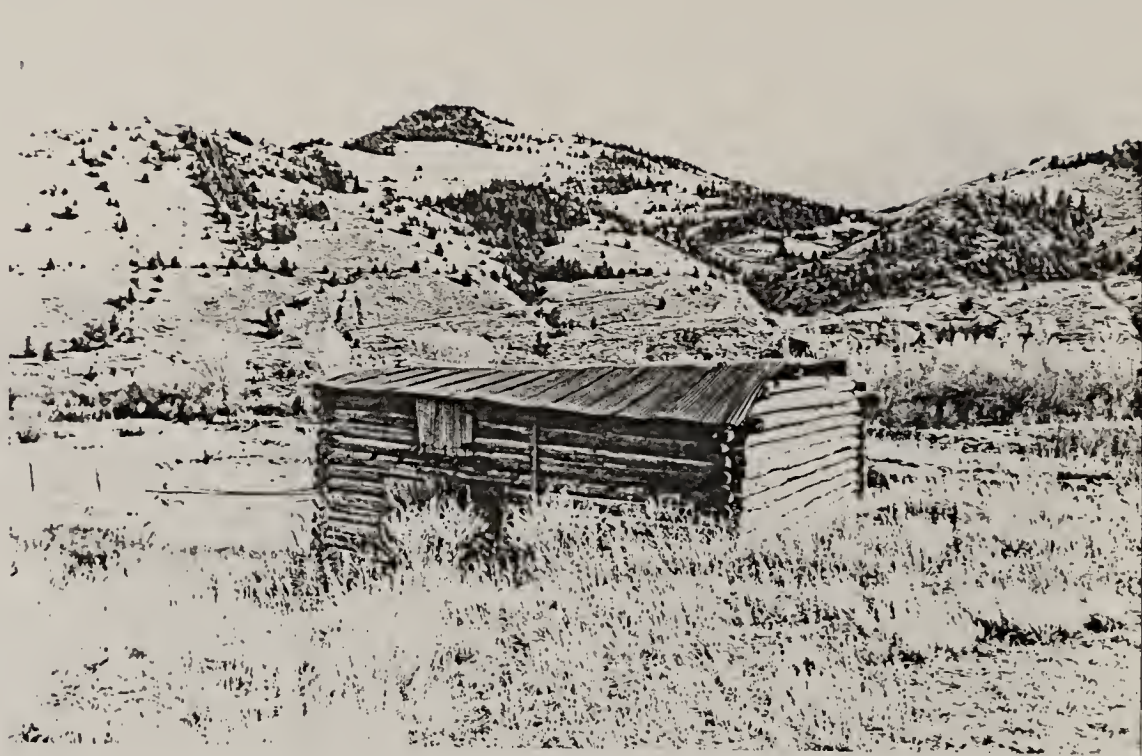
Figure 3-144. Looking south at log stable.

This structure is a one-story log stable with V-notched corners. The cabin had a five-purlin roof (top purlin no longer existing), with corrugated metal roofing. The stable sits on square wood and stone piers, had double wood doors with strap hinges (one remaining), and is in very poor condition.

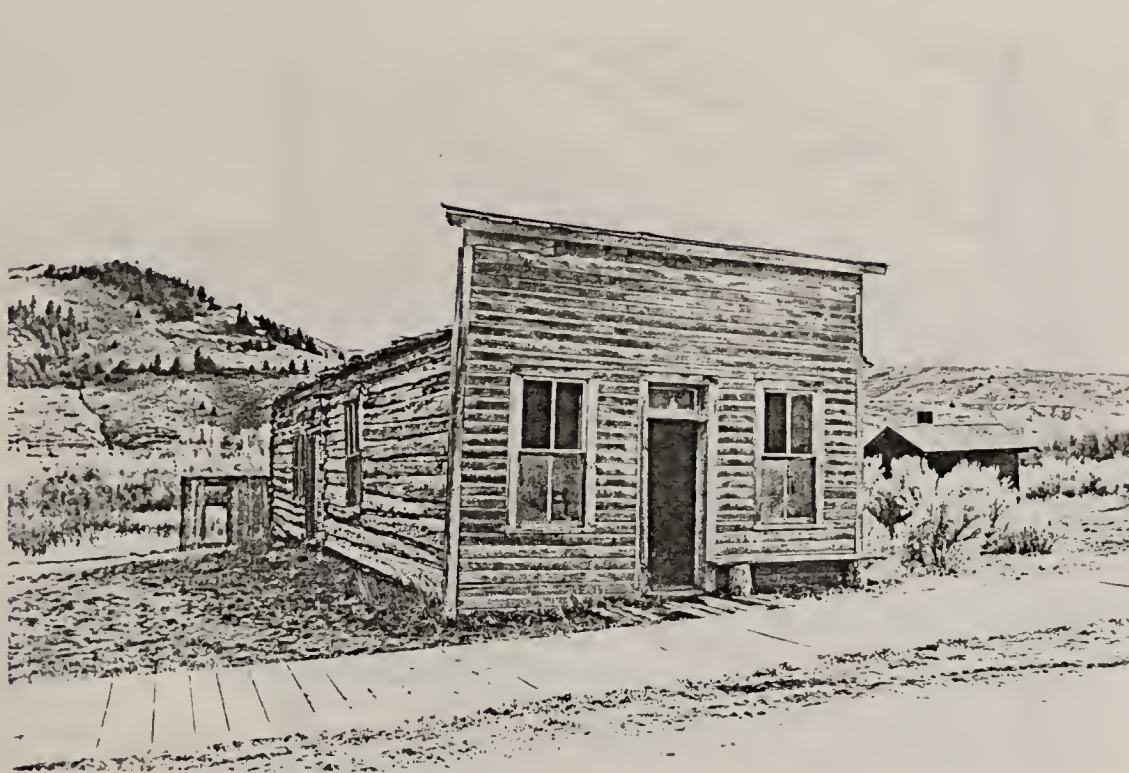
Figure 3-145. Looking southwest at saloon.

This structure is a hand-hewn log and log saloon with shiplap sided false front. Logs are mud daubed with some cement and lime mortar daubing added later. The saloon has a gable roof of five-purlin construction and sod roofing. The roof structure has failed in the center. The north (front) facade has a central wood panel door with transom and flanking windows of two-over-two double-hung type. The facade is topped by a simple entablature with projecting cornice. The rearmost section of the saloon is a later addition of log construction with some bark still adhering. There is an overhanging porch at the rear of the structure. The interior is divided into four rooms, the third of which has a board wainscot. A small frame shed to the rear of the saloon has a board shed roof and board-and-batten siding. The saloon is in poor condition, with water damage and buckled floors. There is no visible foundation.

The property was acquired in 1973 by Fish, Wildlife and Parks. The following stabilization work has been done: 1974--internal bracing of roof structures; 1981--window and door replaced.

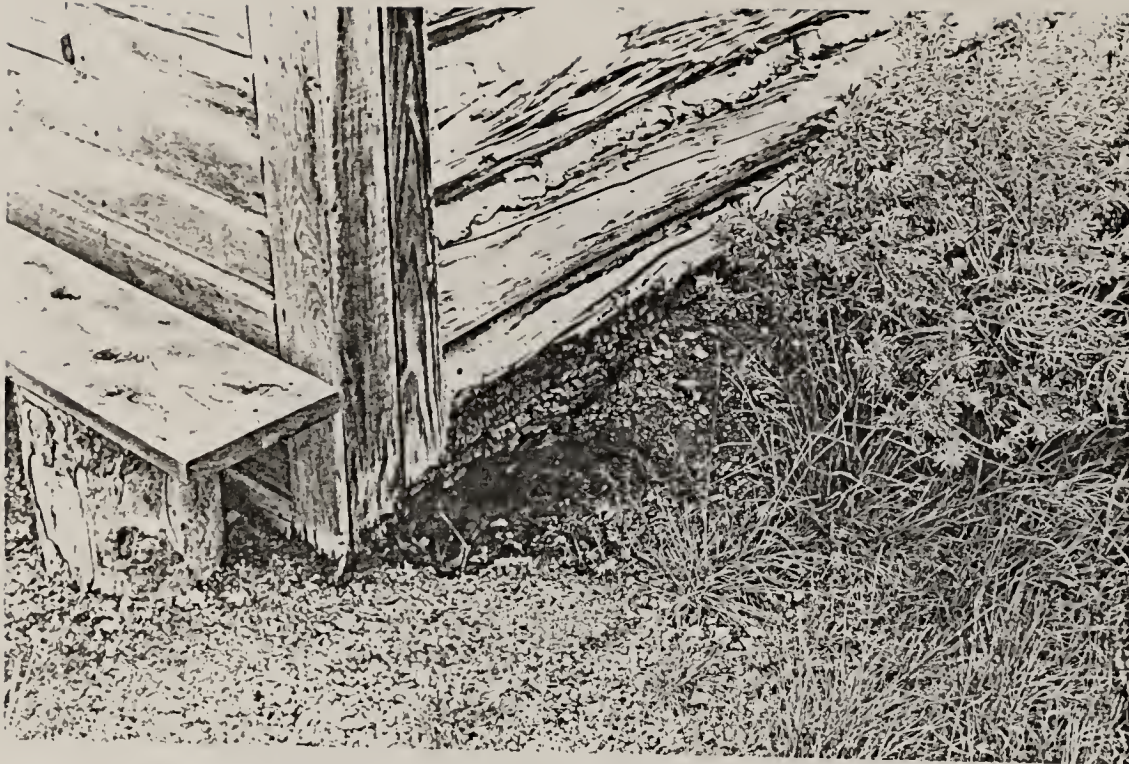
[Mud and cement and
lime mortar daubing]

[Rotting sill logs]

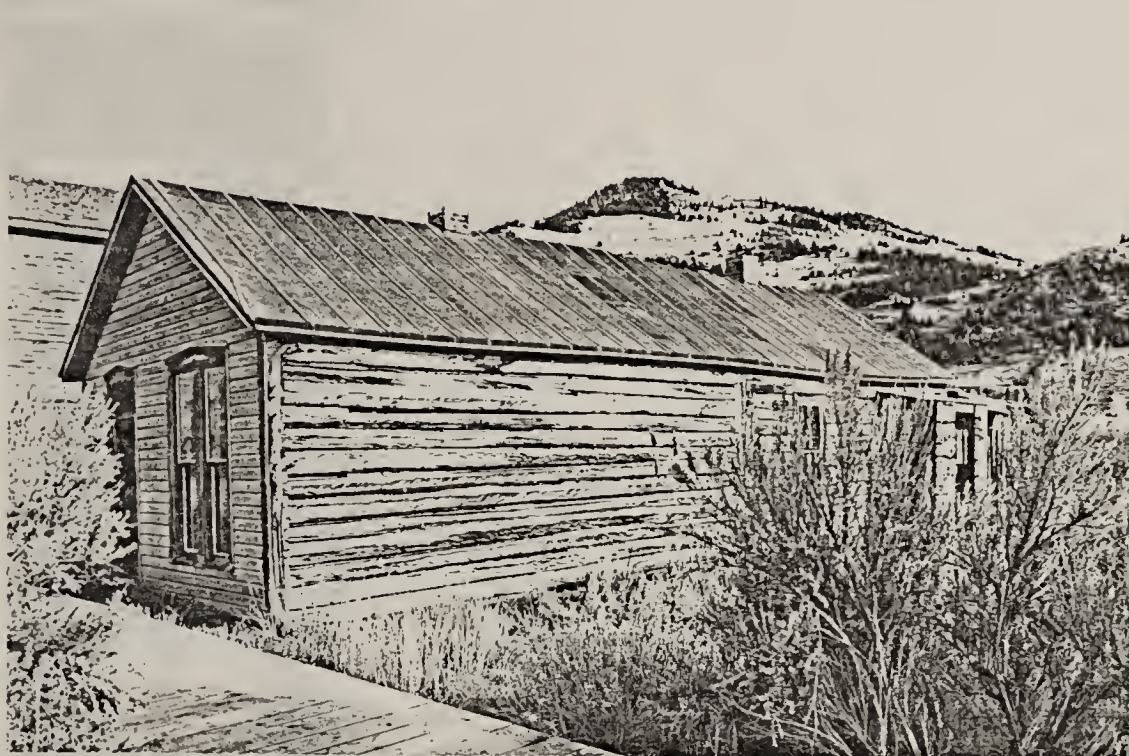
Figure 3-148. Looking southeast at residence.

The residence is in fair to good condition and rests on a stone foundation under the east and west walls. The sill logs are deteriorating and the interior is in poor condition, having suffered some water damage.

The property was acquired by Fish, Wildlife and Parks in 1954 and received a temporary 30 pound felt roof in 1975.

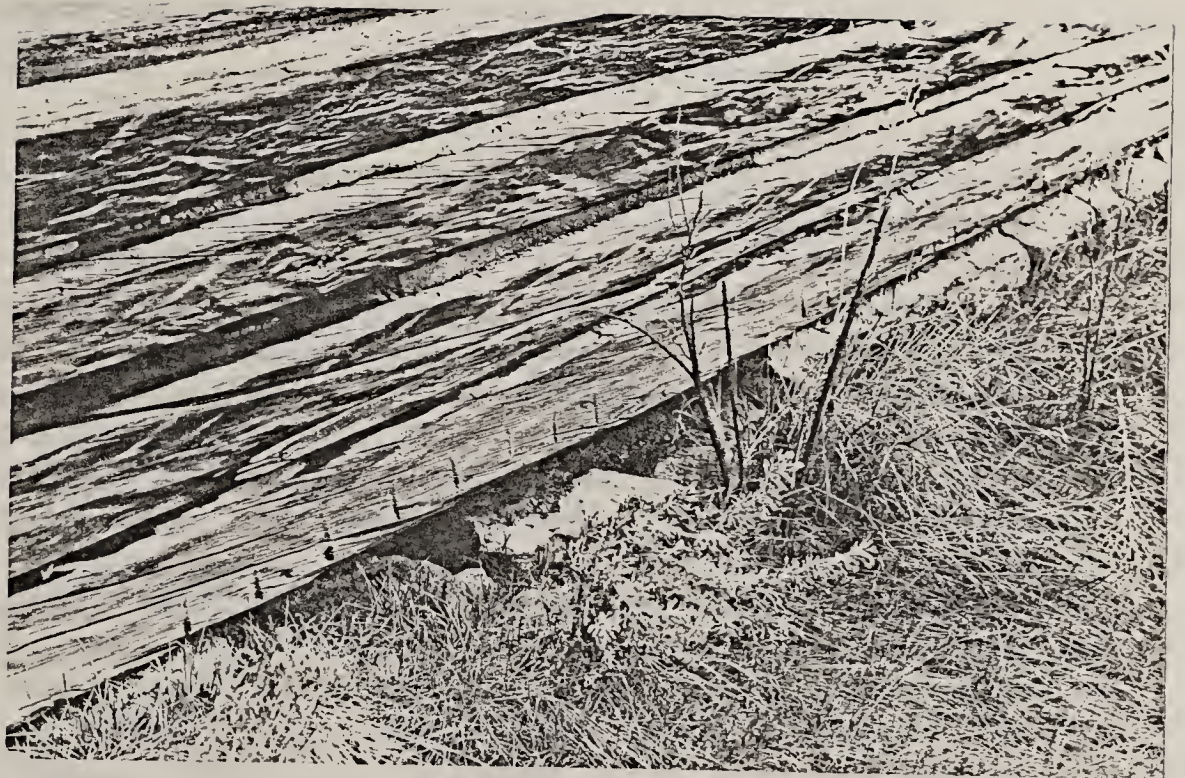
[Deteriorating logs]

[Stone foundation]

Figure 3-151. Sill detail

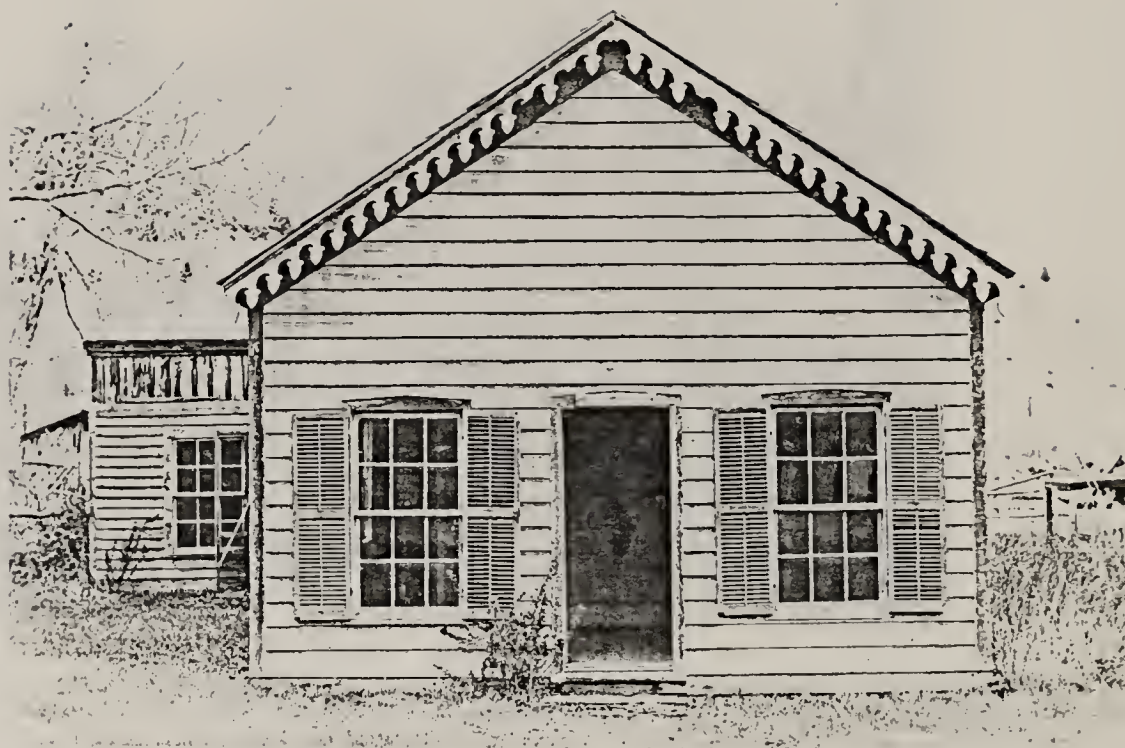
Figure 3-156. Looking southwest at residence.

The property was acquired by Fish, Wildlife and Parks in 1955 and has been stabilized and partially restored as follows: 1972--foundation repair - concrete foundation poured at portions of perimeter; some new roof substructure, new shingles; windows and doors repaired, and west half of verge board reconstructed.
